G-MB 764/63

20 November 1963

SUBJECT: Shipunski Peninsula, Kamchatka USSR, Photo Study

TOP SECRET DESCRIPTION OF ACTIVITY OBSERVED IN SHIPUNSKI PENINSULA
AREA, KAMCHATKA, USSR,

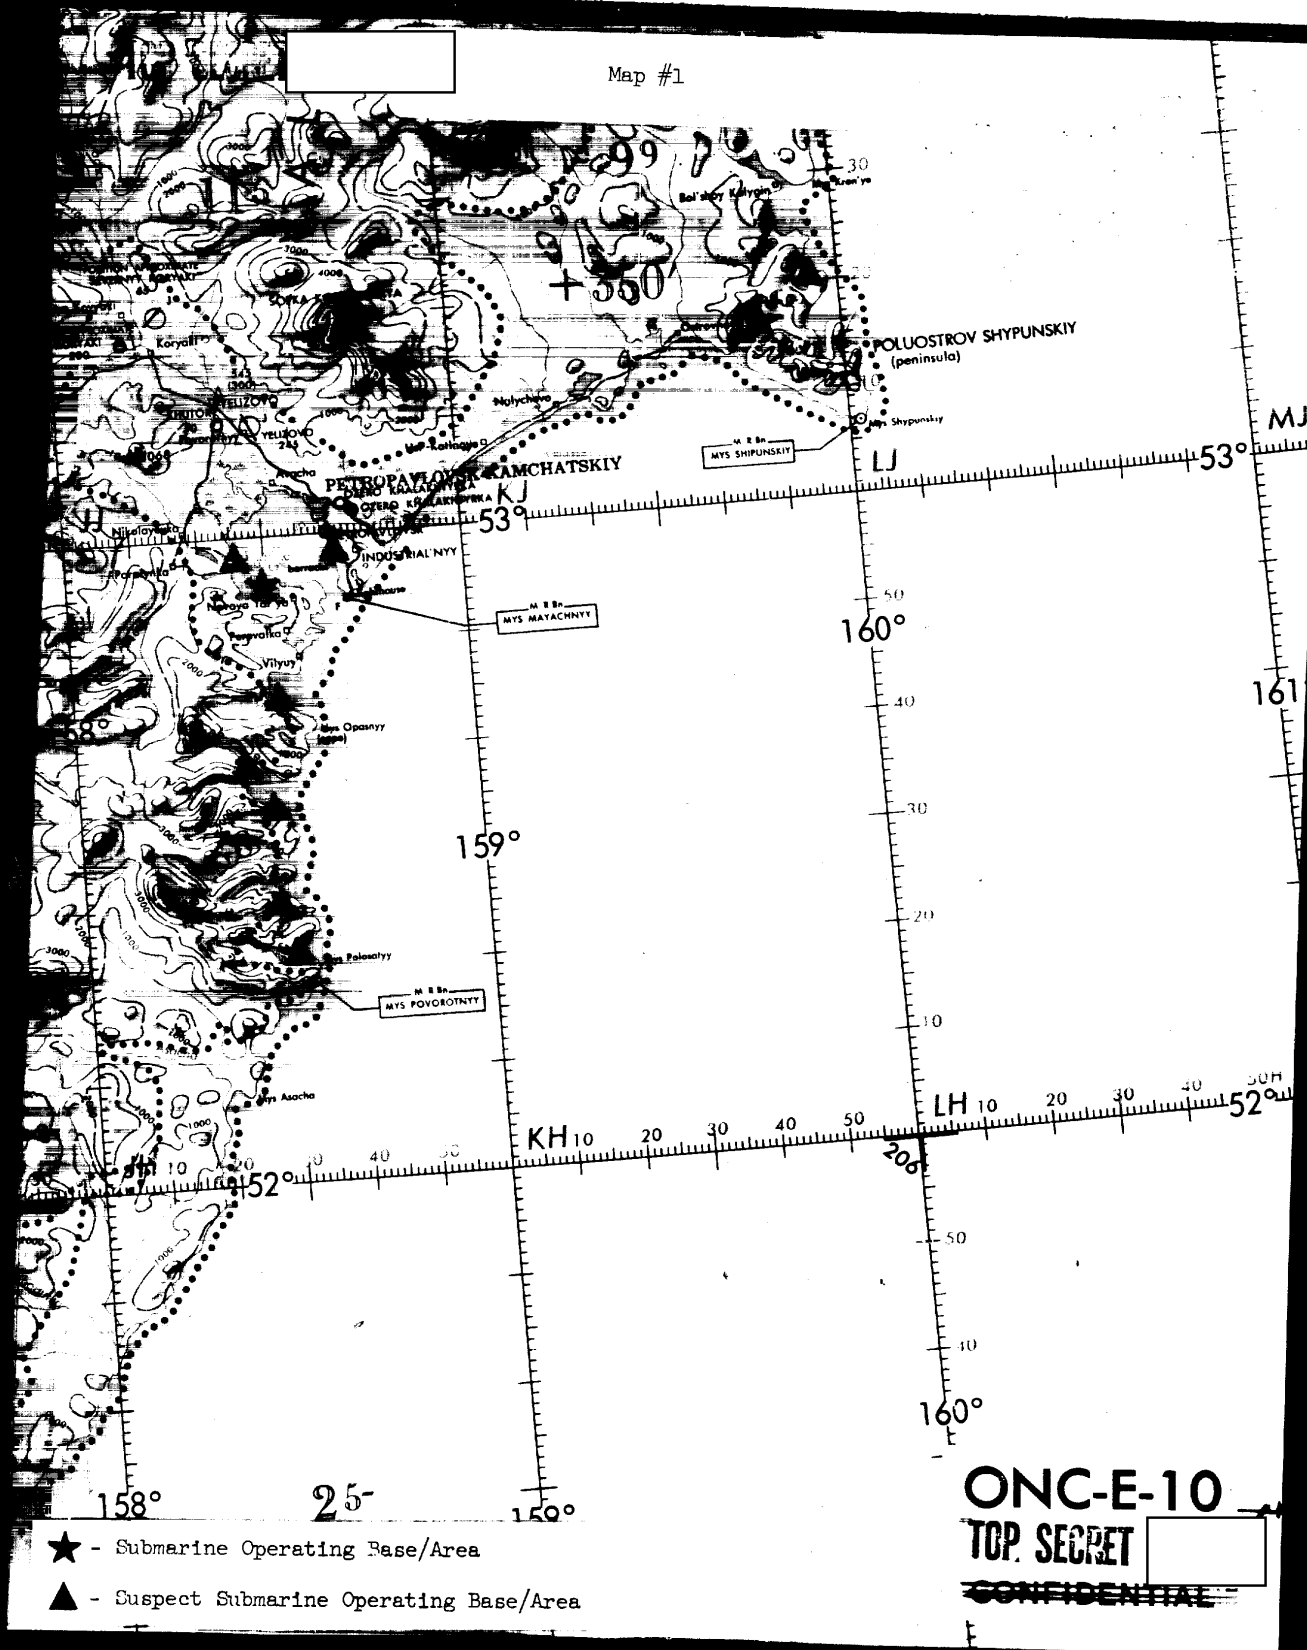
Photo #1 (Mosaic)

Photo No. 1, representing the most recent cloud-free coverage of the entire Shipunski Peninsula, is forwarded as an inclusive small-scale view of the whole area under investigation. It will be noted that photo no. 1 contains a key to the larger scale photos (nos. 2-11) illustrating the specific areas of interest described in this memorandum.

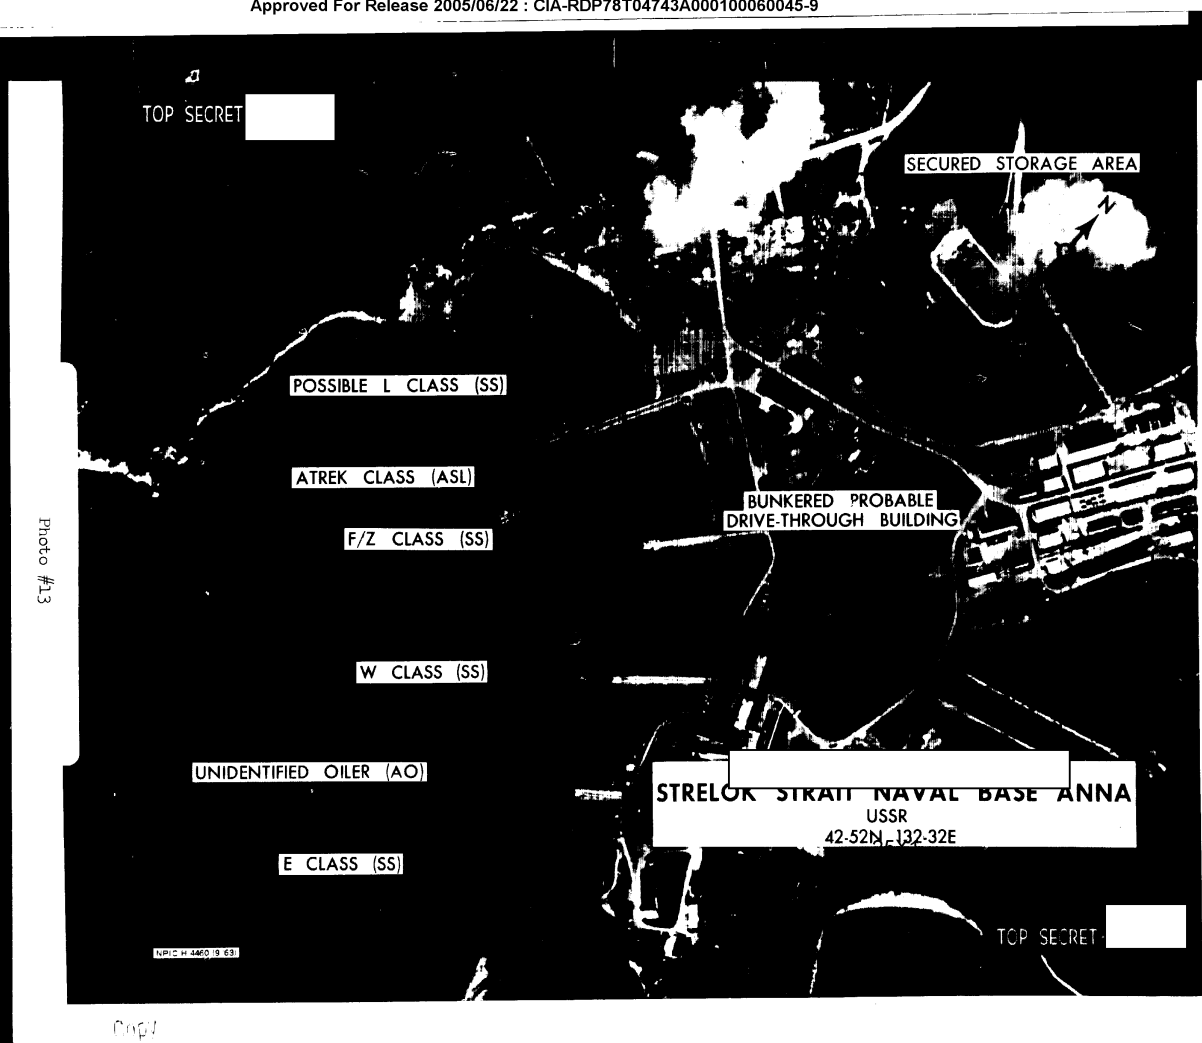
Photo #12

Within the limitations imposed by the differences of terrain and the sequence of construction progress it is, nevertheless, possible to define certain areas of similarity between the possible naval base under construction at Bechevinskaya Bay and the naval (submarine) base located at Pavlovskogo Bay, formerly Strelak Strait, Anna (42 52N 132 32E).

- (1). Both areas are defended by SA-2 SAM sites located within 5 nm of the pier areas.
- (2). The long causewayed pier approach observed in Bechevinskaya Bay (see photo no. 10) appears similar in design to those located at the Strelak Strait Naval Base, Anna (refer to photo no. 11).
- (3). The layout of the barracks support area associated with Area "A", Bechevinskaya Bay (photo no. 10), is similar in design, although not identical, to the general pattern associated with the temporary barracks area constructed at Anna.
- (4). Neither area is served by rail. The Naval Base at Anna is connected by a good road to the railhead at Promyslavka - some 9 nm to the NW - while the Bechevinskaya Bay area is, at present, solely on waterborne re-supply.

SA-2 SAM site

Causewayed pier approaches

Temporary barracks area
